PHILADELPHIA PARISH – BUILDING ASSESSMENTS
 SAINT ANN
 SEPTEMBER 26, 2013
 O&N FILE No. 0962.0331.00

418 Jefferson Ave
 Bristol, Pa 19007
 3925

ST. ANN PARISH

OCTOBER 8, 1980

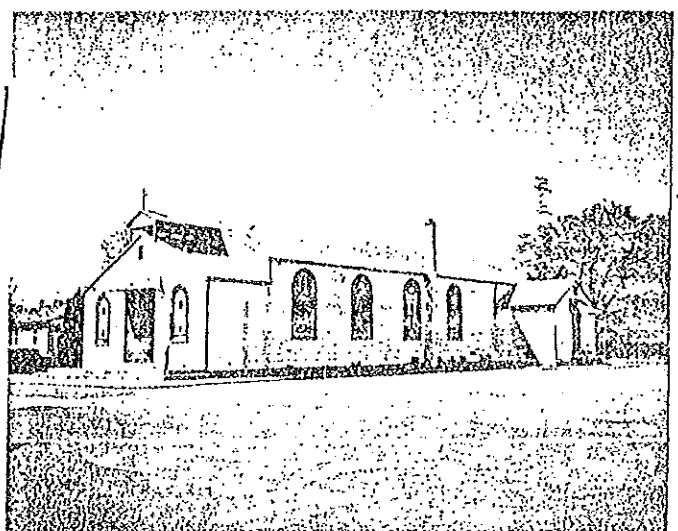
MISSION SACRED HEART OF JESUS

IN TULLYTOWN AND K/A 560 MAIN STREET IS THE SACRED HEART OF JESUS MISSION BUILDING. THIS IS A ONE STORY AND FULL BASEMENT FRAME WITH ASBESTOS SHINGLE SIDING BUILDING, THE ROOF IS GABLE WITH PLANKS ON ORDINARY WOOD JOISTS AND WITH ASPHALT SHINGLES. FLOOR IS DOUBLE BOARDS ON WOOD JOISTS, THE BASEMENT FLOOR IS CONCRETE ON EARTH. INTERIOR WALLS ARE PLASTER BOARD NAILED ON WOOD STUDS AND CEILING JOISTS. OPEN STAIRWAY LEADS FROM THE 1ST FLOOR TO THE BASEMENT. BUILDING IS 26' x 82' AND 30' x 10' WITH 2432 SQ.FT. FIRST FLOOR WHILE THE BASEMENT HAS 2132 SQ.FT. A SIDE DOORWAY ADDS 128 SQ.FT. MAKING THE TOTAL AREA 2560 SQ.FT. BUILT OVER 70 YEARS AGO THE BUILDING IS IN FAIR CONDITION WITH CONSIDERABLE ASBESTOS SIDING MISSING AND BROKEN BY LOCAL CHILDREN.
