**ARM Brickhouse**  
Engineers and Scientists  
An ARM Group Company

April 17, 2023

RE: Project Status Report  
501 Washington Street  
Conshohocken, PA 19428  
ARM Brickhouse Project P00234453.01

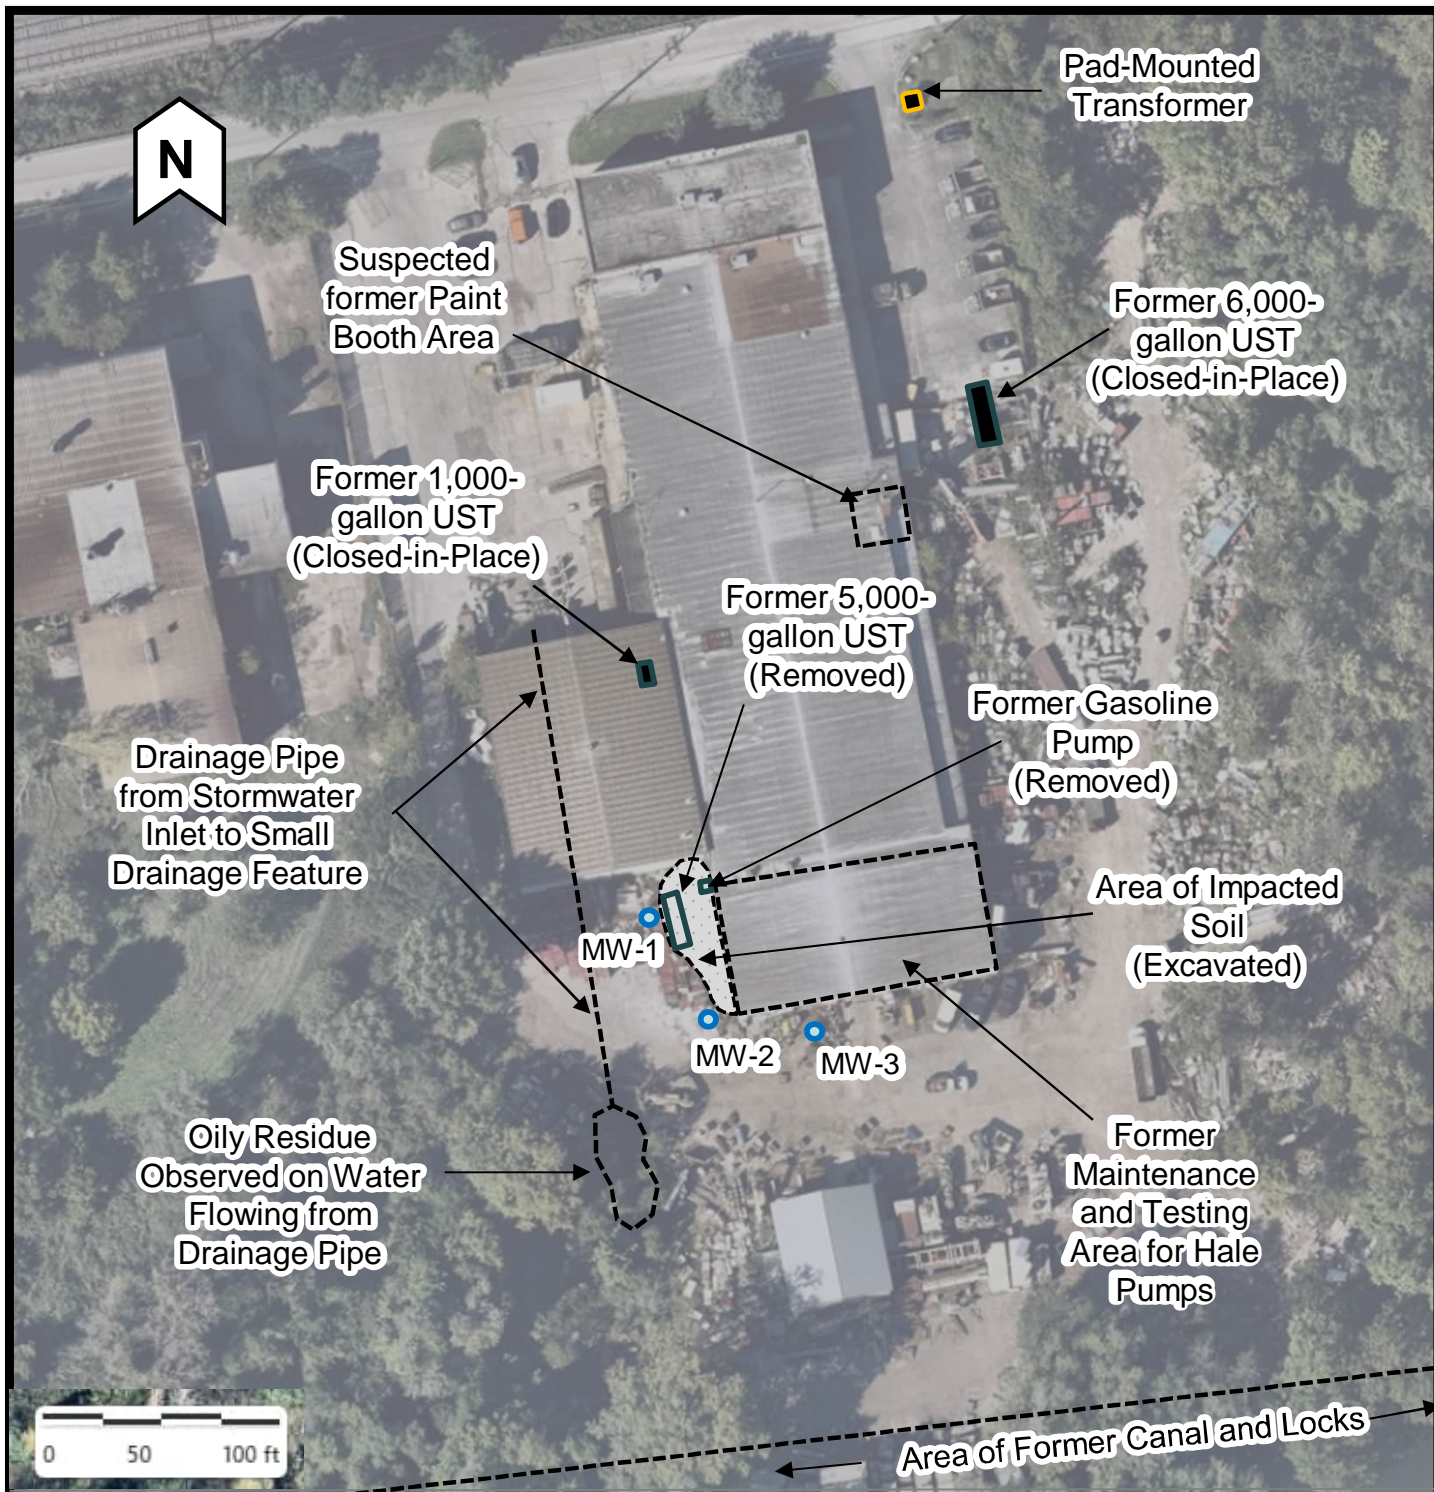
**Figure 4. Site Schematic and Areas of Concern**  
 Source: EDR 2023

The building was previously heated with fuel oil fired boiler. The fuel oil was stored in a 6,000-gallon steel UST located on the east side of the building. It was reported that the UST was closed in place by filling with concrete in 1979. It was reported that the Cardinal Group drilled two soil borings 3 feet from the north and south ends of the tank in 1995. The samples were analyzed for Total Petroleum Hydrocarbons (TPH). The results did not exceed PADEP Action

Hale utilized a 1,000 gallon gasoline UST for unknown purposes. The UST was located outside the western side of the original building. The UST was reportedly closed in place before a building addition was constructed over the UST in 1985. The Cardinal Group drilled four soil borings, one on each side of the tank. Total Petroleum Hydrocarbons were detected between 44 and 330 parts per million. Cardinal concluded that soil remediation was not necessary as the petroleum would likely degrade over time. Similar to the 6,000-gallon heating oil UST, this UST may need to be removed during future land development activities, and a buyer would likely require the collection of additional samples for analysis of currently regulated gasoline UST parameters.

Hale utilized a 5,000-gallon gasoline UST to add fuel to fire pumps for testing prior to sale. The UST was located at the southwestern edge of the building. This UST was removed by the Cardinal Group in 1995. Soil contamination beneath the gasoline dispenser was observed. Three hundred tons of soil was excavated and shipped off site for disposal.

Gasoline was observed in the excavation pit on the groundwater surface. PADEP was notified of the release. Three groundwater wells were installed. These wells were sampled for gasoline parameters four times per year from 1995 through 2004. Data shows contaminant levels decreasing over time. The last monitoring report in the PADEP file from 2004 recommends “Pursue Demonstration of Attainment for PADEP statewide human health non-residential standard in a nonuse aquifer”. There is no record that this recommendation was pursued.

Hale painted the fire pumps in a paint room reportedly located along the eastern side of the building. They were listed as a large quantity generator of hazardous waste, which we suspect

was related to the use of paint thinners, paint equipment cleaning solvents, and waste paint. Industrial painting operation during their time of operation are associated with releases of hazardous materials to the environment. A limited soil sampling campaign conducted by Cardinal in 1995 at the area of some stained soil near the loading dock did not identify contamination by volatile organic compounds. However, a buyer would likely require a more comprehensive sampling campaign for volatile organic compounds in soil and groundwater targeted toward this area of the property.

Surface water runoff drains from the northwestern parking lot and a portion of adjoining property to the west into a storm pipe that runs beneath the western building addition. Where the pipe daylighted at the southwest area of the property an oil residue was observed on the water surface. The source of the oil residue is unknown, but it may be released to the former UST that was closed in place under the building addition. A buyer would likely require an investigation into the source of the residue along with appropriate remedial actions depending on the results of that investigation.

Levels in force at the time. While the available data indicates this UST was closed properly without obvious evidence of releases, future development activities may necessitate the removal of this UST. A Geophysics Investigation to locate the perimeter of the UST along with additional soil bores to allow the collection of samples for currently regulated heating oil compounds would likely be required by a buyer of the property.

A buyer would likely require a groundwater investigation in this area to determine current conditions. The wells were not observed during our inspection. However, we were not aware of their existence at the time and they may still be present and available for sampling. If not, new monitoring wells would be necessary to determine current conditions. If residual impacts above Act 2 statewide standards remain in the groundwater, pursuit of a relief of cleanup would likely be necessary.

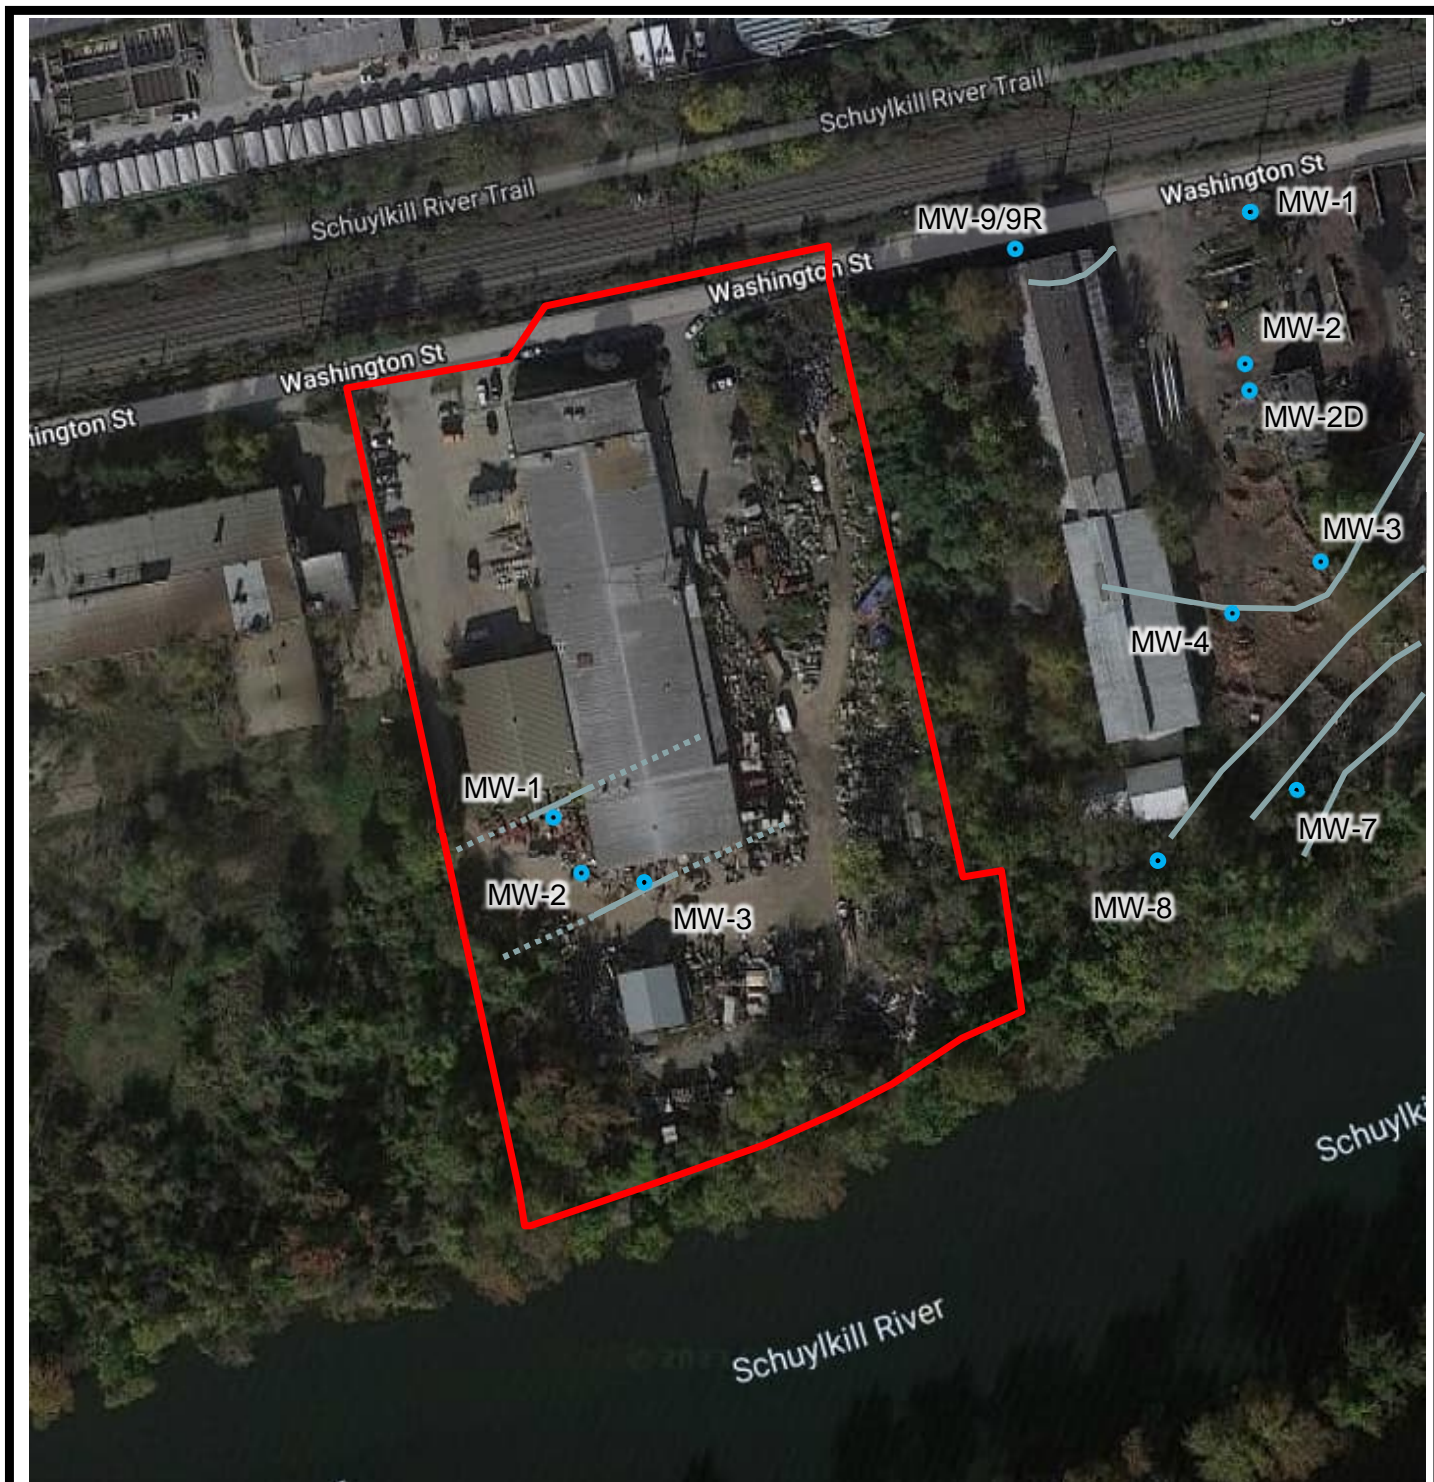
**Figure 5. Groundwater Gradient at Subject Property and Adjoining Property**  
 Source: Roux Associates, Inc. Act 2 Combined Report August 28, 2020

Site investigation reports and other correspondence filed with the state alleged that some of the chlorinated solvent contamination was believed to be migrating onto their property from an upgradient property. ARM Brickhouse's review of groundwater flow and contaminant distribution maps indicate the most likely source to be properties to the north of Washington Avenue. However, a buyer of the subject property could require that groundwater investigations

be conducted to confirm that the contamination discovered at 601 Washington Avenue was not derived from the 501 Washington Avenue property. The drilling and testing of one or more monitoring wells along the eastern edge of the subject property would be necessary to complete that effort.

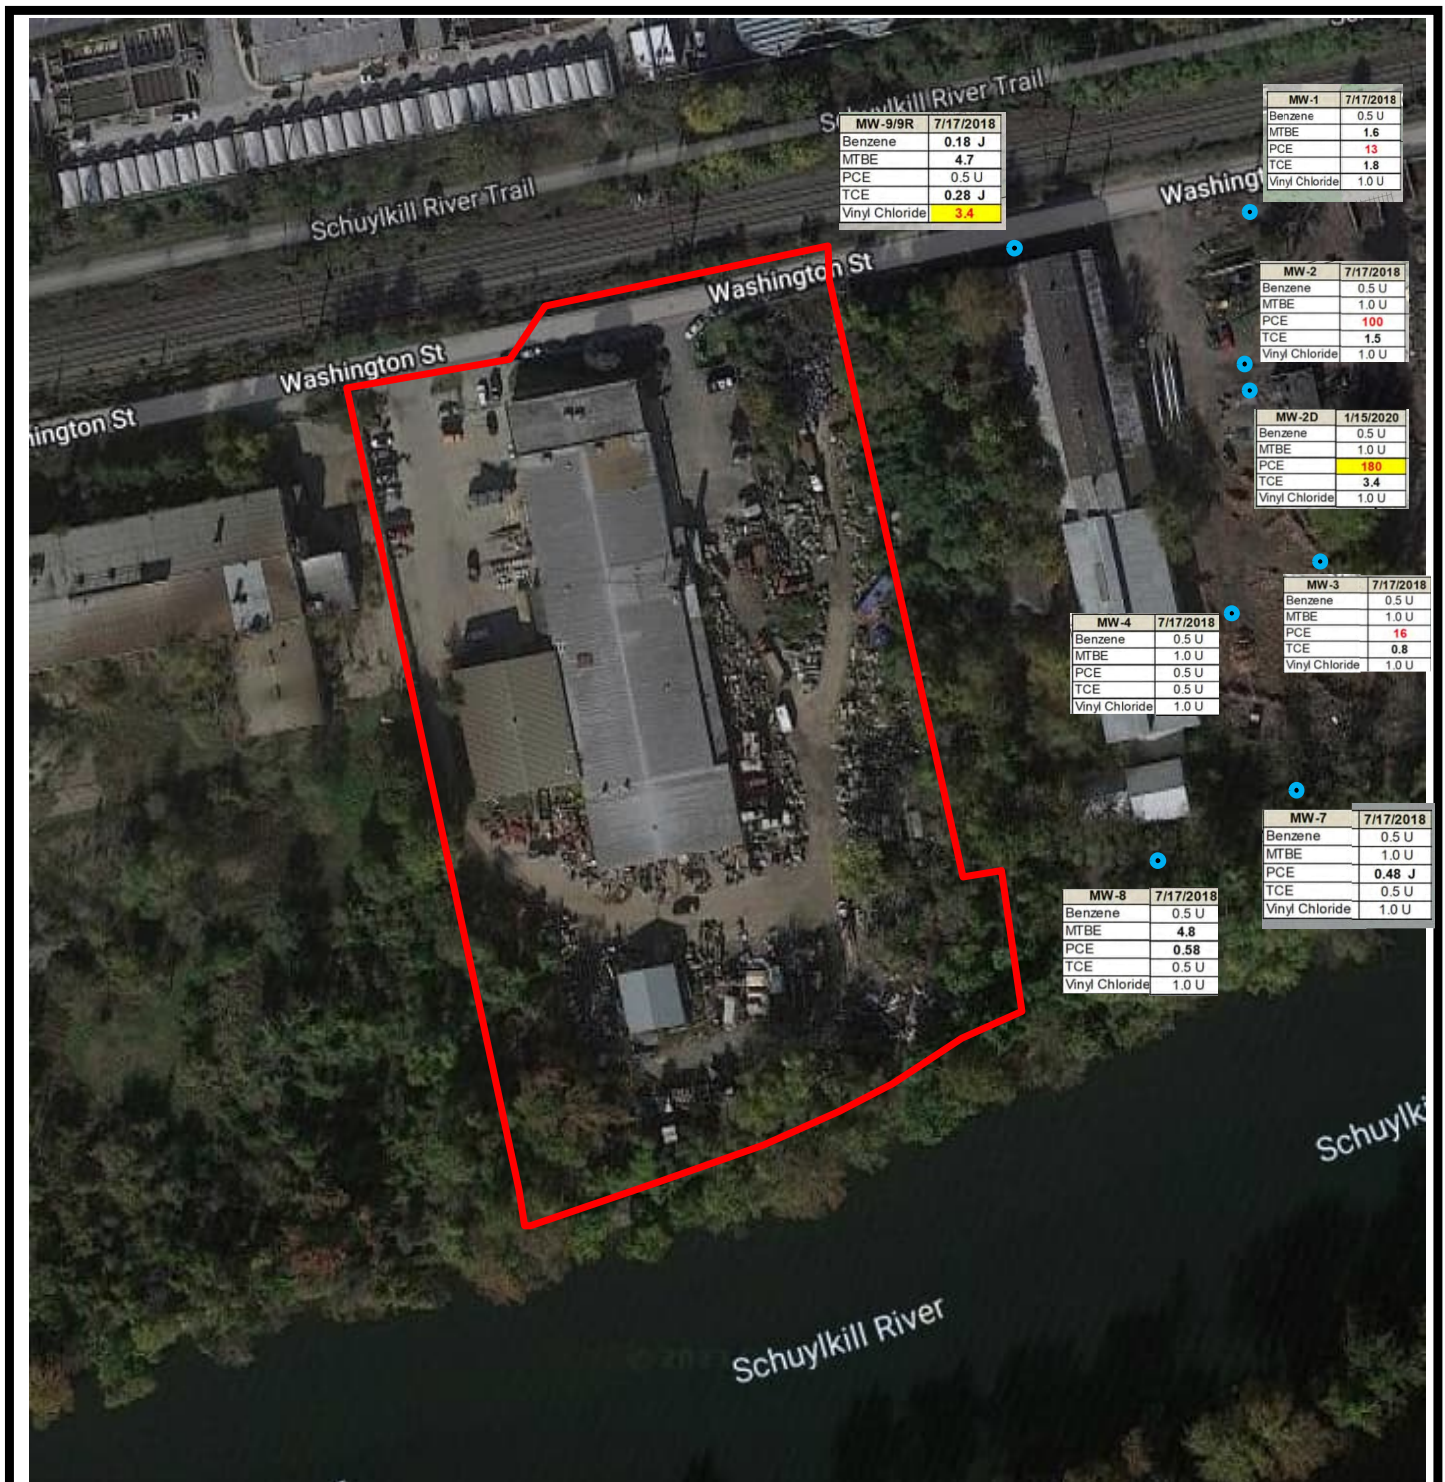
**Figure 6. VOC Concentrations on 601 Washington**  
 Source: Roux Associates, Inc. Act 2 Combined Report August 28, 2020

The adjoining property to the east, 601 Washington Avenue, was once operated as the Philadelphia Steel and Iron Works, as well as the Frassoni Iron Works, manufacturers of pressure and storage tanks for water, oil, and gas. This property has been remediated through the Land Recycling and Environmental Remediation Standards Act (Act 2). As part of that process, they drilled and tested 12 groundwater monitoring wells. The groundwater was found to contain both petroleum related compounds, as well as chlorinated volatile organic compounds.
