FINAL EXISTING RESOURCES & SITE ANALYSIS

PLAN OF PROPERTY FOR HETTIE HERZOG

WEST VINCENT TOWNSHIP CHESTER COUNTY, PA

Edward B. Walsh & Associates, Inc.
CIVIL ENGINEERS & SURVEYORS
Lionville Professional Center
125 Doulin Forge Road
Exton, Pennsylvania 19341
Phone: (610) 903-0060
Fax: (610) 903-0080

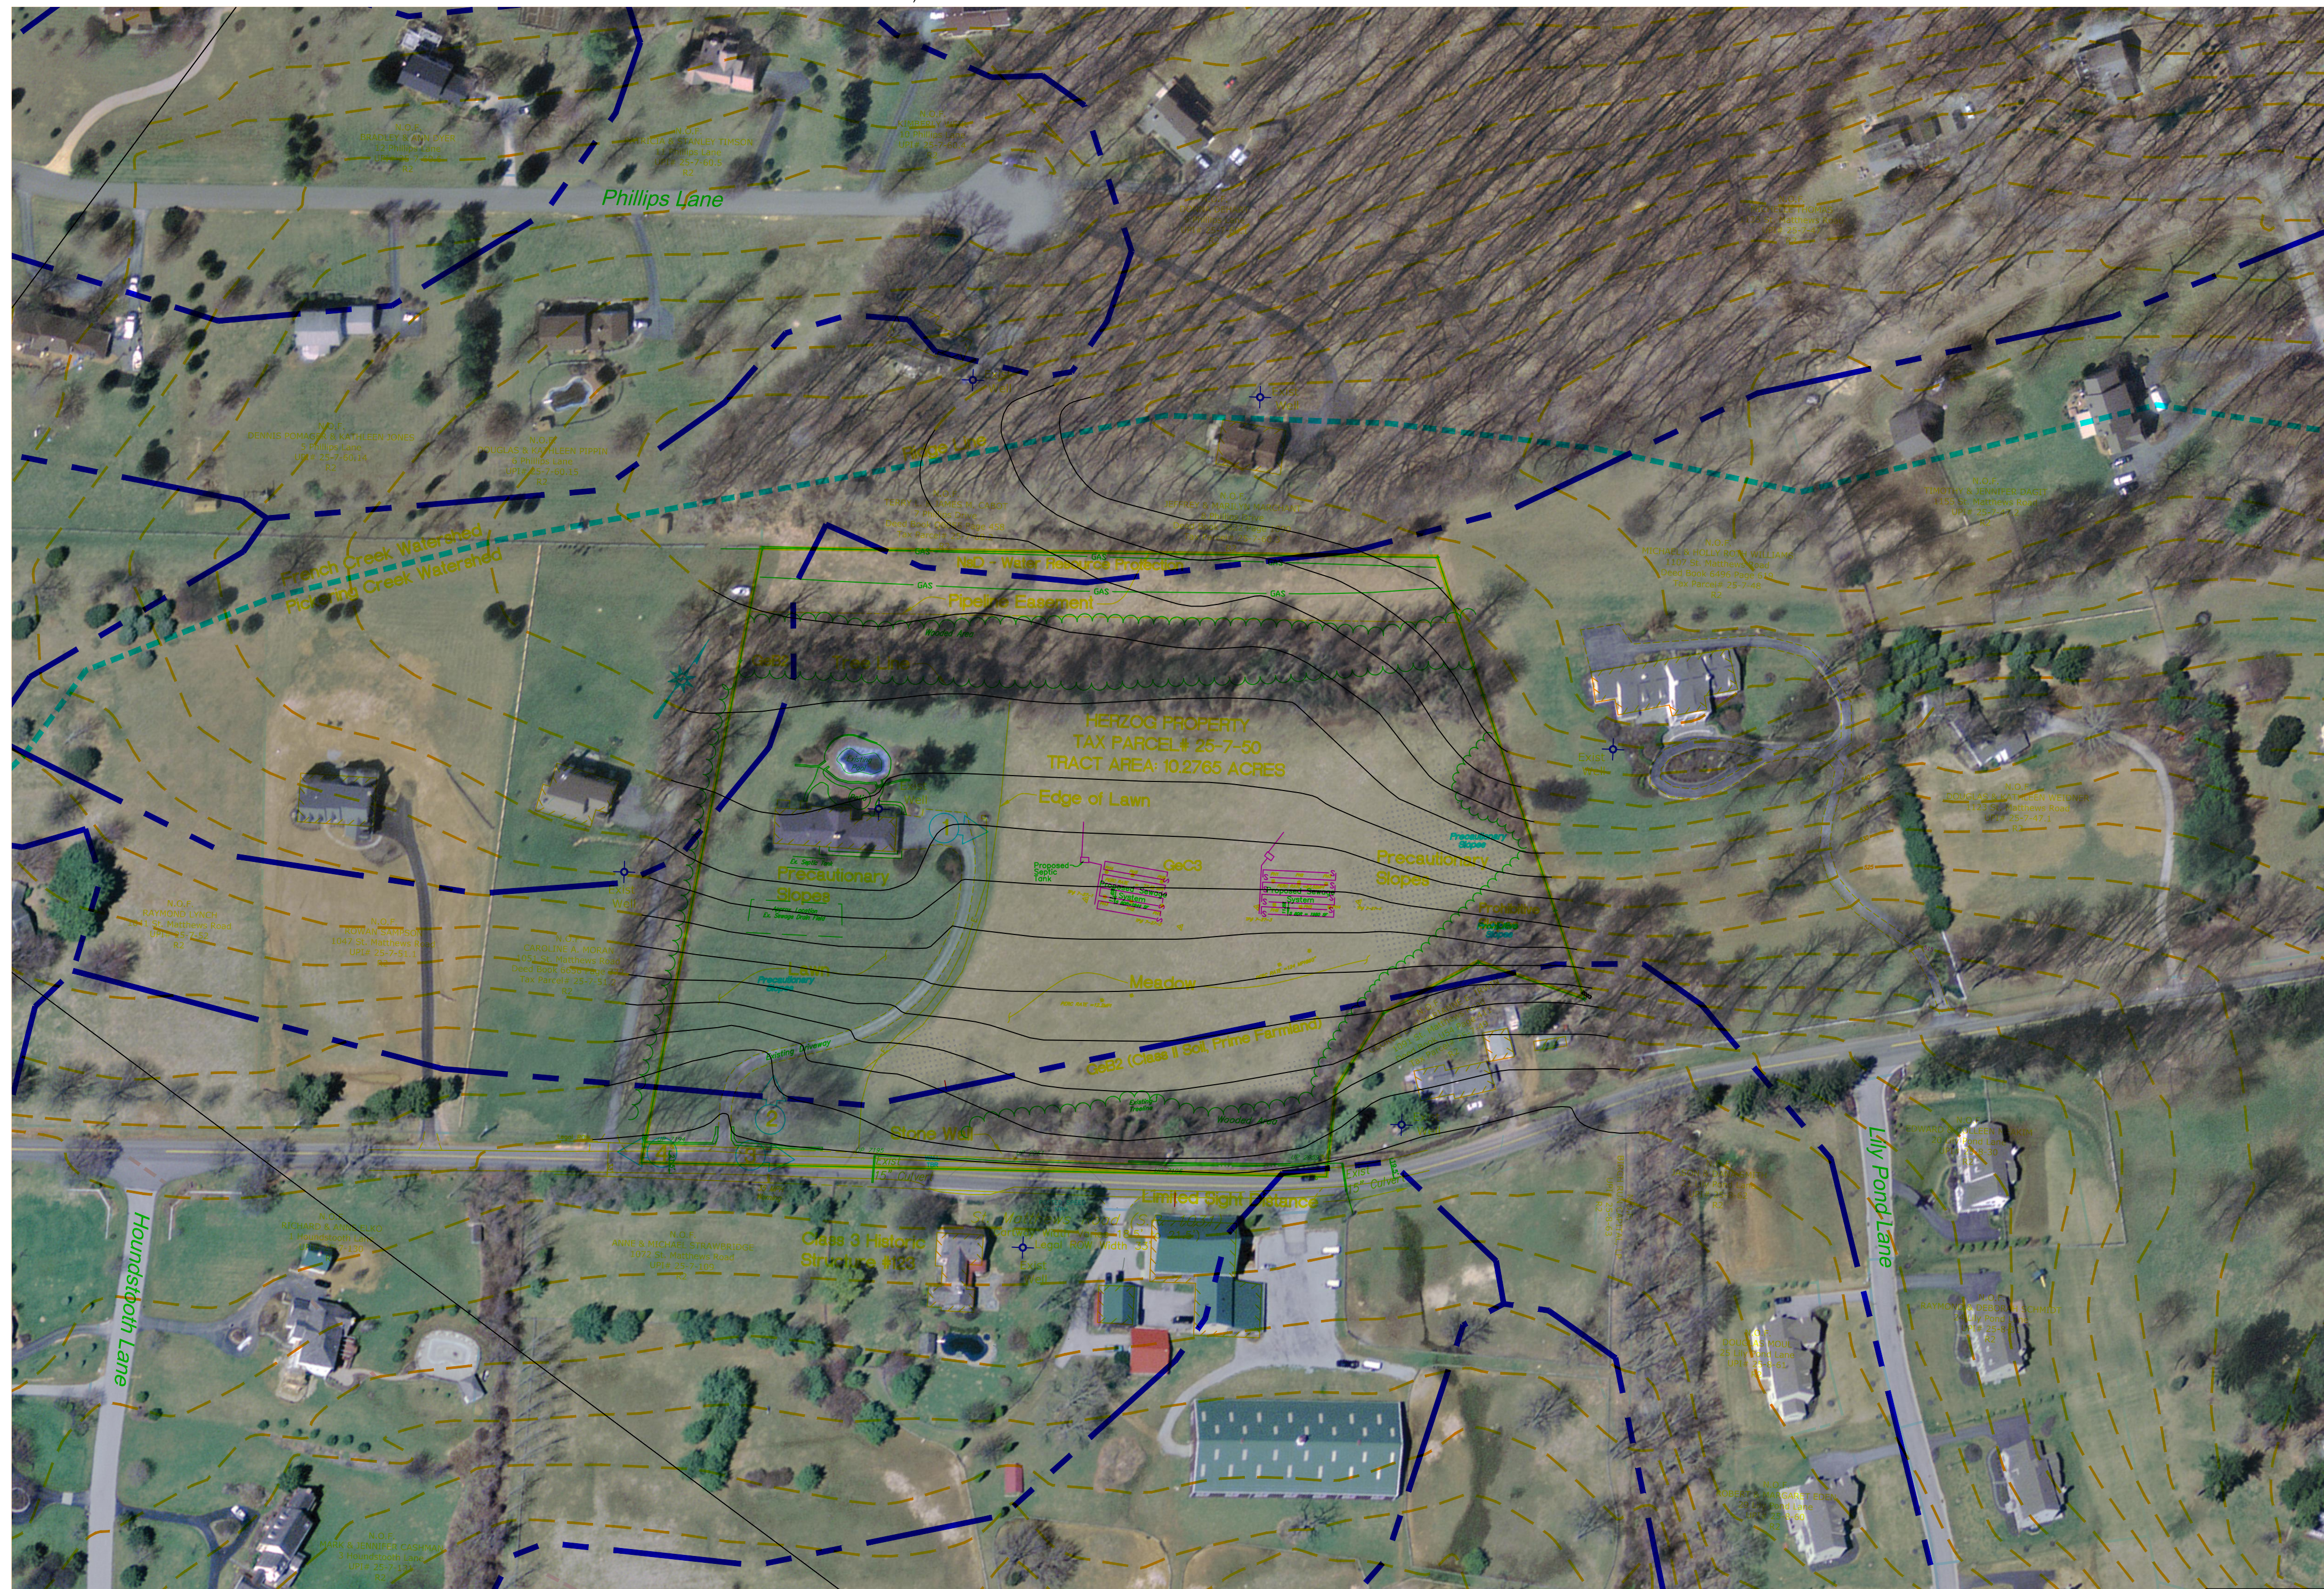
SITE ANALYSIS NOTES:

1. Property boundary and topographic information taken from a field survey performed by Ash Associates of Kimberton, Pennsylvania April 5, 2006. See list of Plan References.

SITE GEOLOGY:

Piedmont Upland Section of the Piedmont Physiographic Province
Pre-Cambrian graphite gneiss (Pickering Gneiss) and marble
As there is no evidence to the contrary, groundwater flow is assumed to run parallel with topography
