**DOWNINGTOWN AREA SCHOOL DISTRICT**

**SUMMARY REPORT  
DUE DILIGENCE INVESTIGATIONS**

**SIEMENS PROPERTY  
UWCHLAN TOWNSHIP,  
CHESTER COUNTY, PENNSYLVANIA**

**ISSUED: MAY 25, 2006  
NAVE NEWELL NO: 2006-010.02**

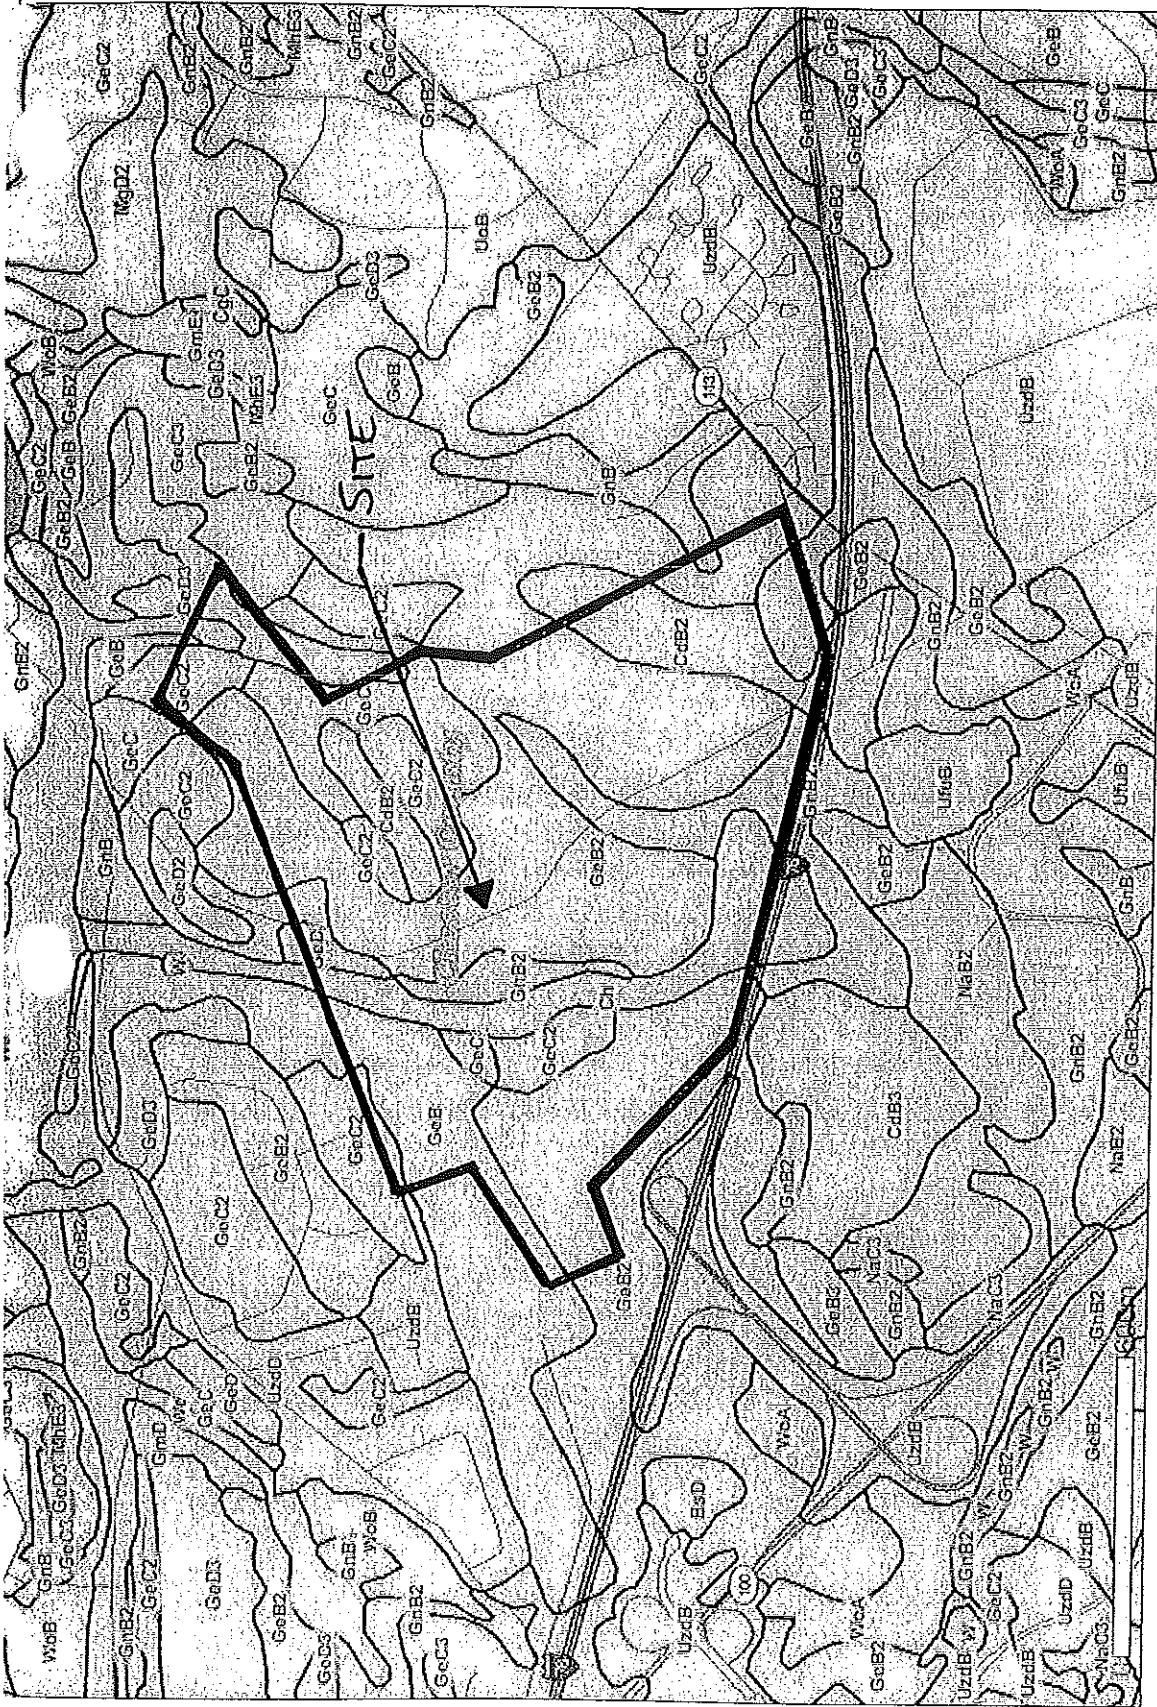
Map Scale 1:16863, 1 inch = 1405 feet  
Created by SoilMap, 5/18/2006 9:23:56 AM

The site soils, as described in the Chester County Soils map, are silt loam with moderate permeability rates and moderate to gentle slopes. These soil types typically are well drained with moderate infiltration rates. Since the subject property has been historically utilized as farmland, RT Environmental recommends the collection of surface soil samples. These samples would be analyzed for the presence of pesticides, arsenic, and lead, to determine if the past farming operations have impacted the property's soils. The impact to the site soils are in relation to excavation. Testing is recommended to determine if excavated materials meet PaDEP Fill Policy Criteria and Limits. RT Environmental recommends no materials be moved offsite, or redeposited onsite, unless it is confirmed that constituents of concern in soils meet the applicable limits.

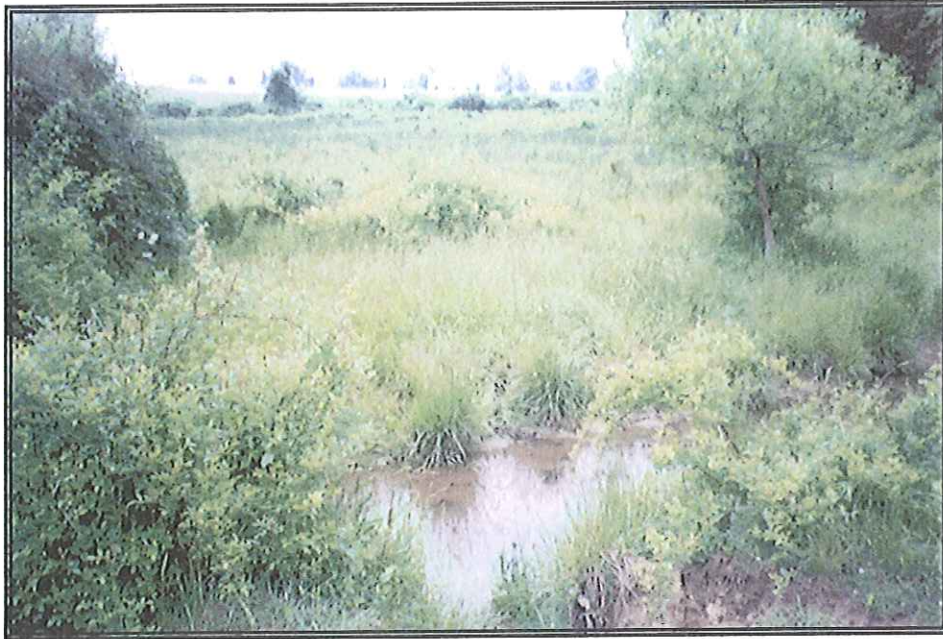
**Figure 3.** The main stream running through the Siemens property is visible in the foreground of the photograph. This stream marked the eastern edge of the potential bog turtle habitat. The wet sedge/rush meadow is evident in the center of the photograph.

One area was found to have potential for the bog turtle. This area was located at the northern end of the site. It was bordered to the east by the stream (**Figure 3**), to the north by a large tree line, and to the west an plowed agricultural field. The agricultural field was separated from the bog by a hedgerow of multiflora rose (**Figure 4**). Vegetation in the bog consisted largely of various sedge species, skunk cabbage, soft rush, and some red maple. This area had an open canopy, a soft, muddy substrate, indicator plants, and appeared spring fed. Several small rivulets had visible surface water flow (**Figure 5**). A wet sedge meadow adjoined this habitat, forming an area approximately two acres in size with potential bog turtle habitat. Due to the quality of the habitat, this area on the Siemens property was given a **Z-Scale rank of 3**. This habitat ranking indicates that a Phase II bog turtle survey is required to determine presence or absence.

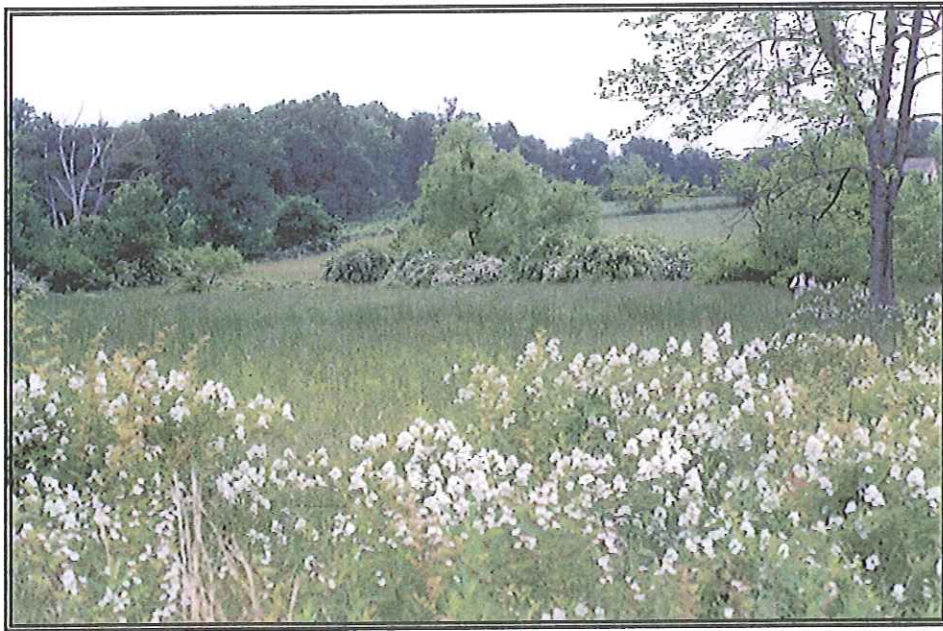
**Figure 4.** A view of the wet sedge/rush meadow from within the potential bog turtle habitat. The stream, although not visible here, is in the center of the photograph flowing from right to left. It is bordered by several shrub species and multiflora rose. The forest edge marks the northern boundary of the potential bog turtle habitat. Multiflora rose in bloom is visible in the foreground.

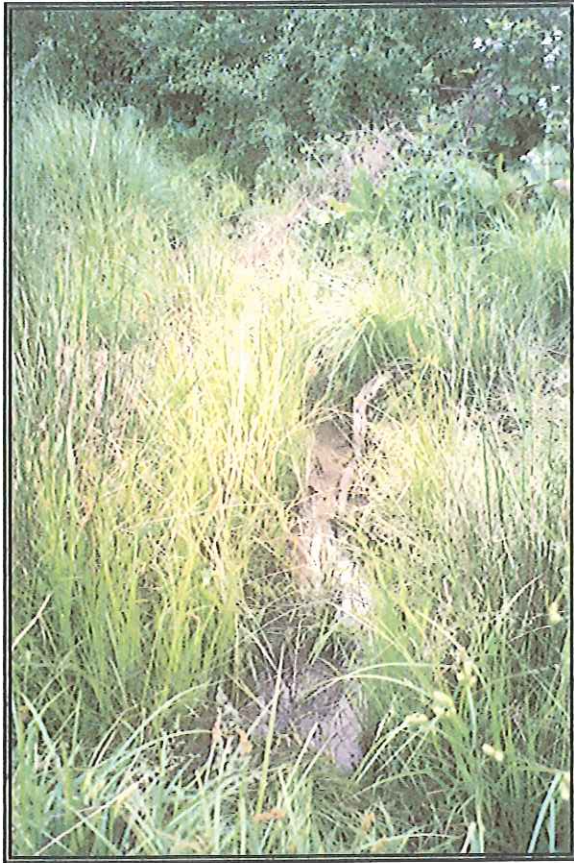
**Figure 5.** One of the main rivulets in the seep-fed portion of the bog. Several small rivulets were found in this area, each with some slow surface flow. Microhabitats such as this provided some of the most potential habitat on the study area.

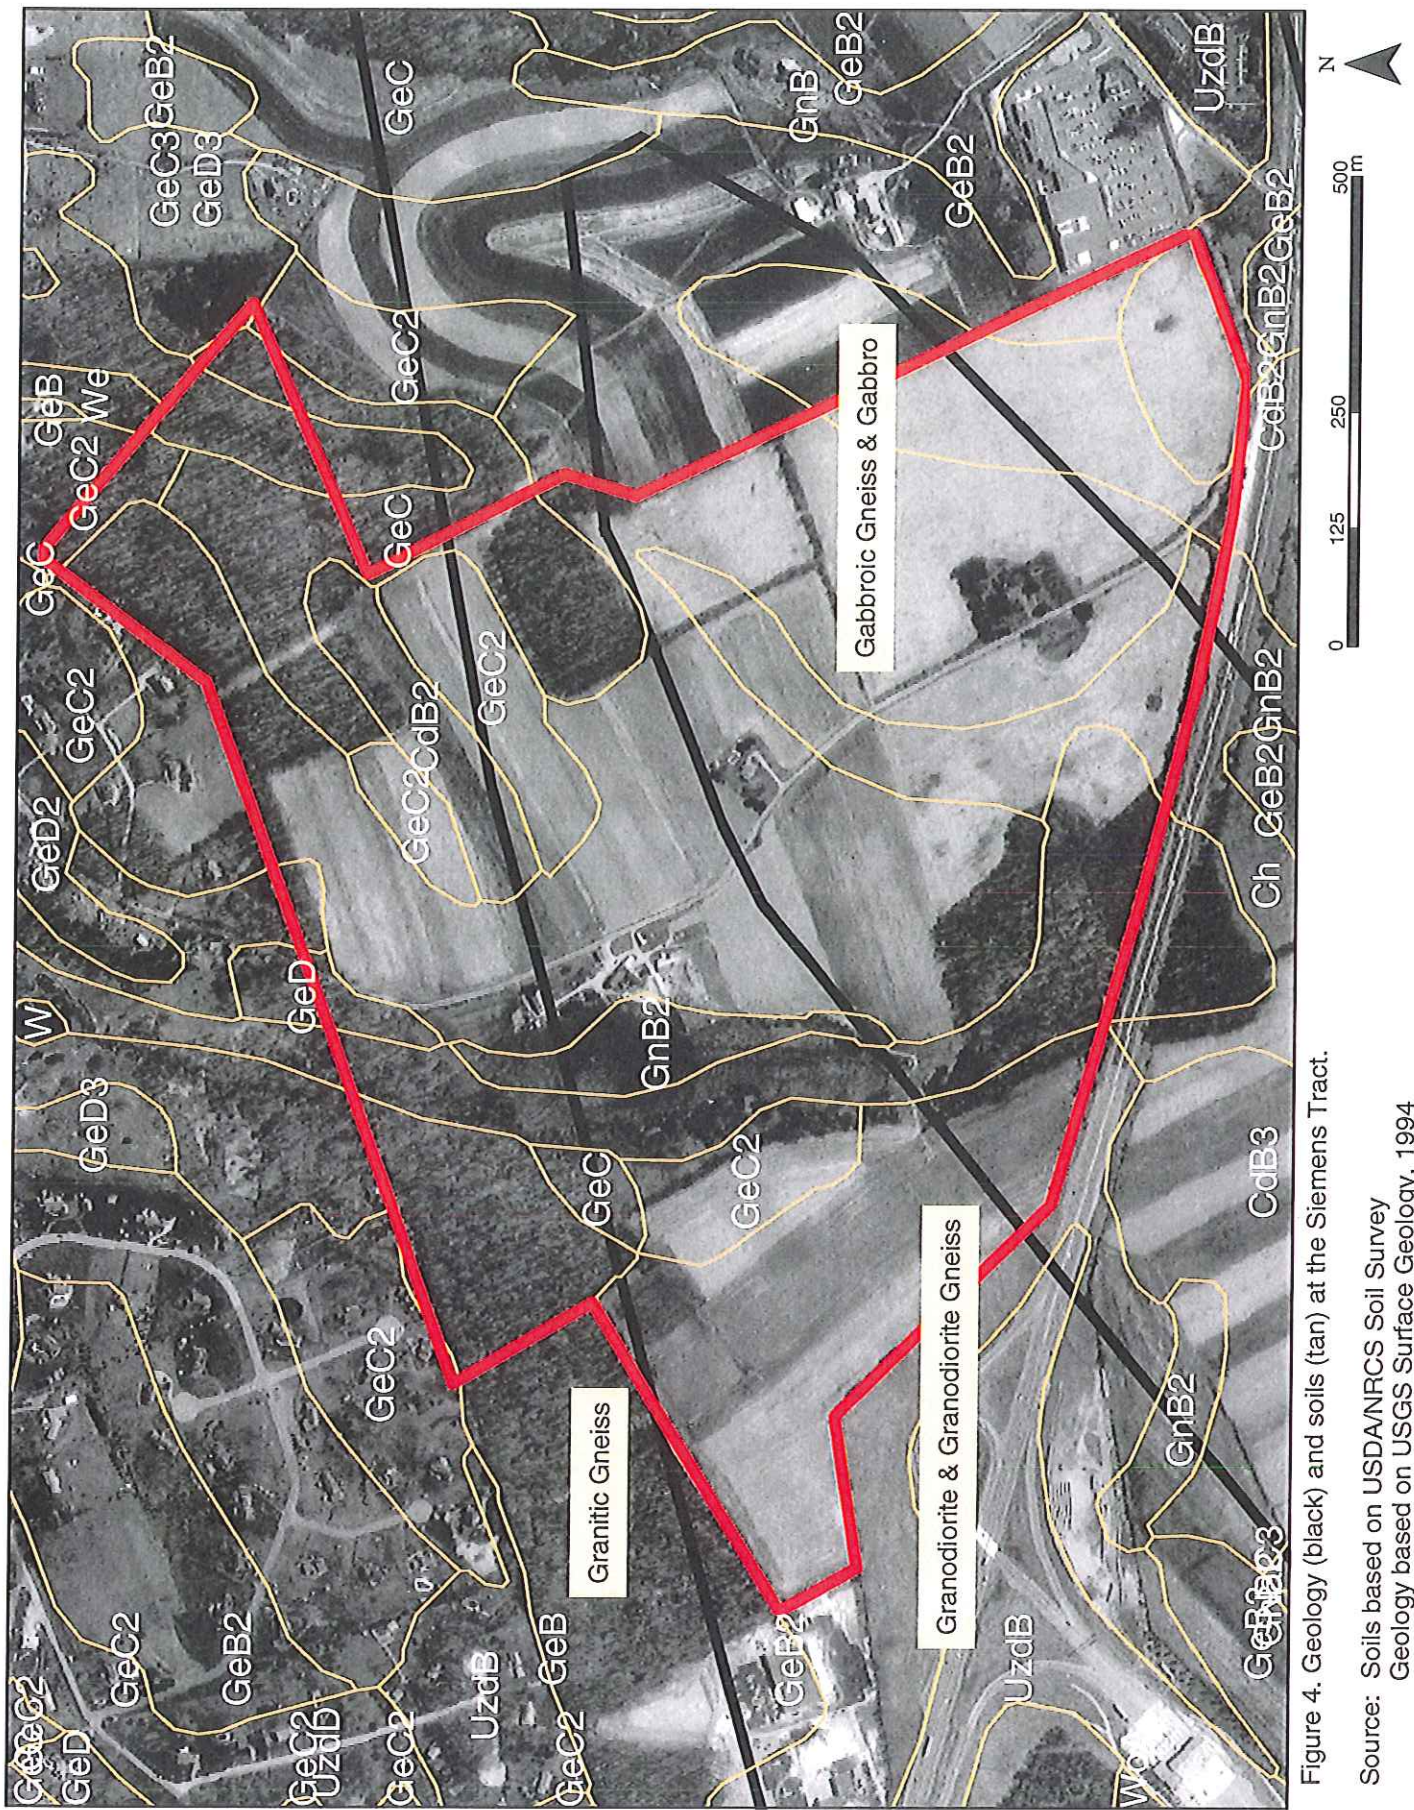
Figure 4. Geology (black) and soils (tan) at the Siemens Tract.

Source: Soils based on USDA/NRCS Soil Survey  
 Geology based on USGS Surface Geology, 1994

Most of the wetlands bordering the main tributary coincide with Chewacla (Ch) soils, a mapping unit not listed as a hydric soil. Glenelg channery silt loam (GeB2 and Ge\*) underlie most of the on site uplands and borders portions of the Eastern Tributary. Glenelg is a mapping unit found in moderately deep to well-drained soils, developed in material weathered mostly from granite, gneiss and mica schist. It is typically observed on slopes with a grade of 3-8%. A narrow strip of Glenville (Gn\*) soils borders the Chewacla soils to the northeast. Glenville silt loam (GnB2) is a mapping unit with hydric inclusions. Glenville soils are deep, moderately well drained found in uplands and developed in material weathered from granite, schist and gneiss. Hydric soils named Wehadkee (We) underlie the Eastern Tributary as it exits the site.

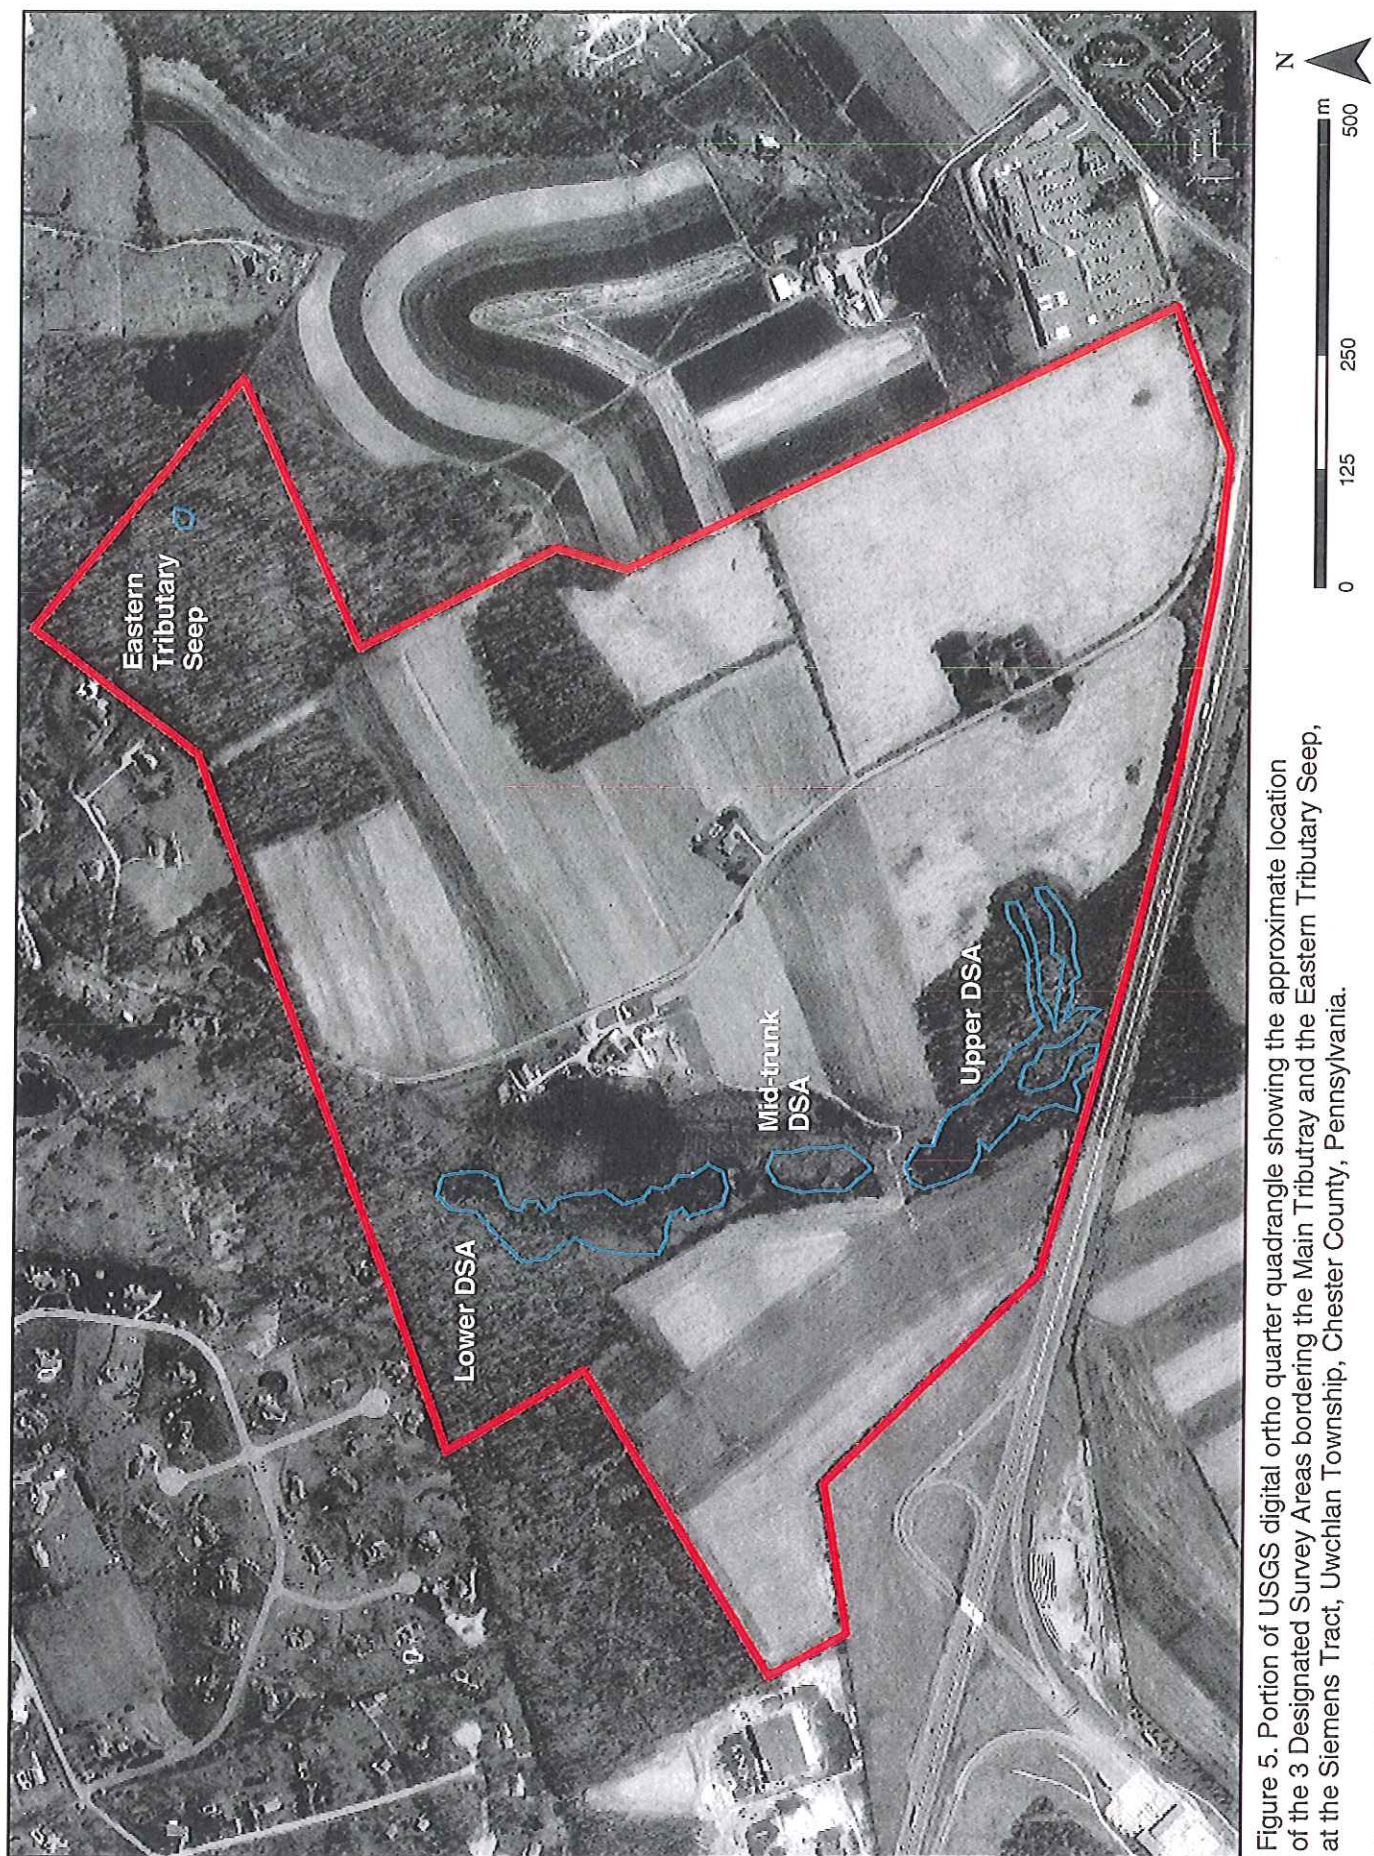
Figure 5. Portion of USGS digital ortho quarter quadrangle showing the approximate location of the 3 Designated Survey Areas bordering the Main Tributary and the Eastern Tributary Seep, at the Siemens Tract, Uwchlan Township, Chester County, Pennsylvania.

Hydrology in the Lower DSA turned out to be very ephemeral, except where fed by the main tributary or any one of the many larger rivulets. The emergent portion was the driest from the first visit, and became drier over the course of the study. There was little hydrologic heterogeneity in the marsh itself. The surface lacked inundation almost throughout. When present, saturation was only several inches deep. Moisture was evidently confined to a shallow subsurface layer. No burrows or subterranean cavities were noted in the marsh. Rivulets mostly traversed through brushy, woody vegetation along the southern and northern edge of the marsh. Rivulets varied in their flow. Some were barely flowing and consisted of shallow pools interrupted by mud-flats. Larger channels connected to the stream or fed by small springs and/or seepages were usually found in the southern and northern ends of this DSA. The northern portion of the DSA, below the mature woodlands, contained larger spring-fed seeps and channels.
