PHASE I ENVIRONMENTAL SITE ASSESSMENT

1180 CHURCH ROAD

Lansdale, Pennsylvania 19446

EMG Project #: 84445.07R-001.050

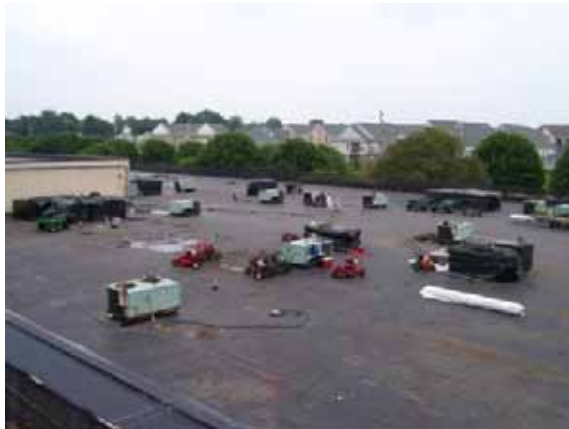
Photo #5:	Roof with HVAC units
-----------	----------------------

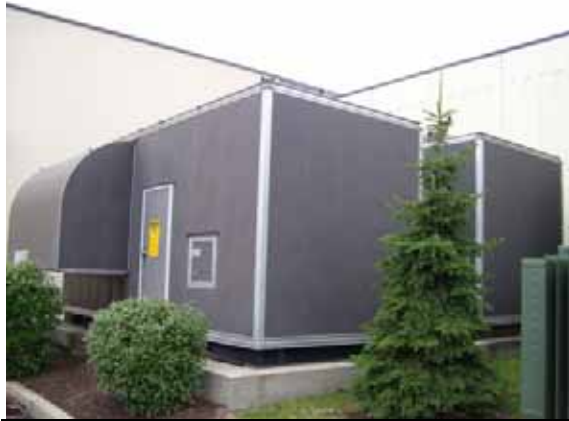
Photo #7:	Natural gas fired emergency generators
-----------	--

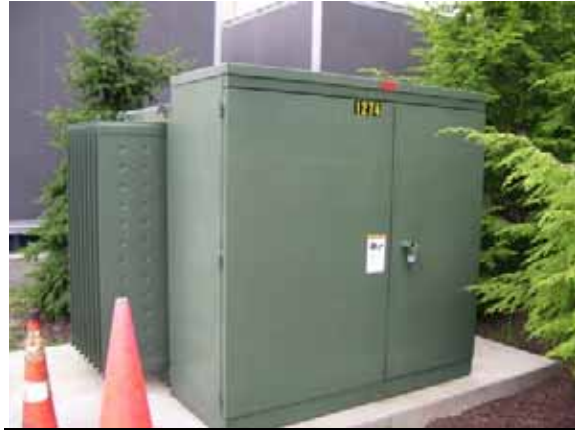
The Project is supplied with underground secondary electrical service from four pad-mounted vaulted exterior electrical transformers. The transformers are designated as the property of PECO and two transformers are designated as the property of Lansdale Electric Company, the public utility and are labeled Non-PCB. The units should be periodically inspected for leakage. If leakage is visible, the Project owner/manager should contact the public utility, which will remediate the situation. Should the units have to be replaced, the utility is responsible, provided the cause is equipment failure, not customer misuse. No leakage of the transformers was observed at the time of the assessment.

Photo #8:	Typical transformer
-----------	---------------------

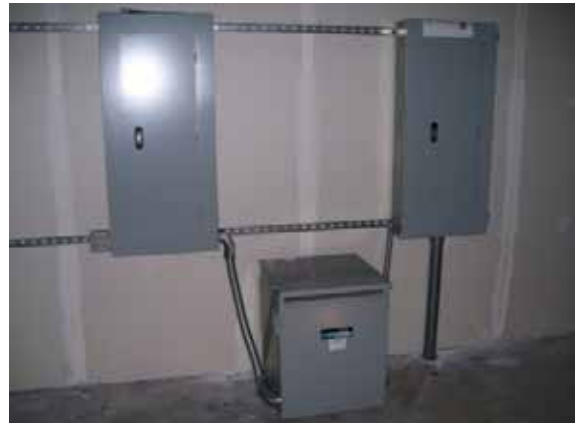
Photo #10:	Dry type transformer
------------	----------------------

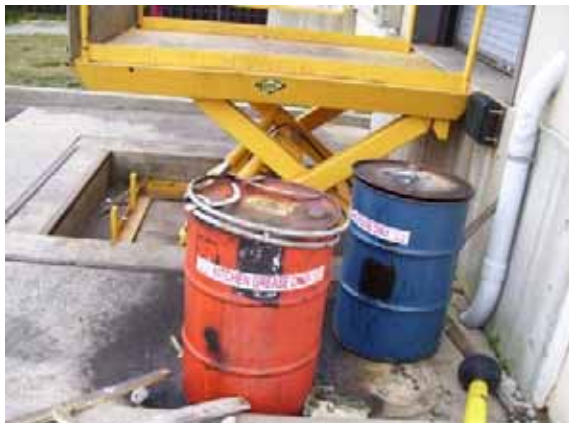
No evidence of spills or staining was observed in the area of waste generation or pre-disposal storage, with the exception of the following: Minor staining was observed in the area of the waste cooking grease drums. The staining was surficial in nature. In addition, the asphalt surfaces appeared intact and no cracks were observed in the areas of waste generation or pre-disposal storage.

Photo #11:	Kitchen grease
------------	----------------

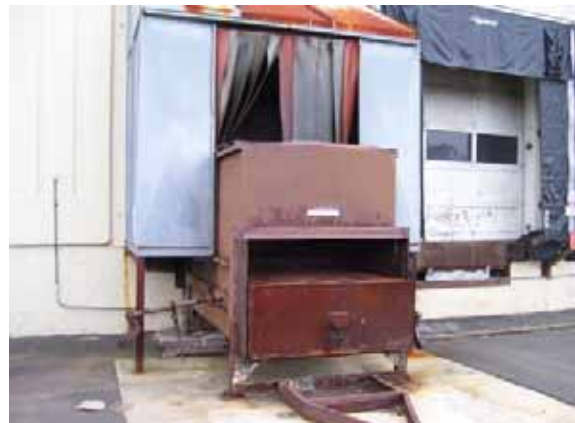
An out of service hydraulic trash compactor is located at the Project. PCB-containing hydraulic fluid has not been manufactured since 1977. Therefore, based on the date of installation (1989), PCB-containing hydraulic fluid is not likely to be found in the compactor operating system. No visual indication of leakage was observed in the area of the equipment.

Photo #12:	Trash compactor
------------	-----------------

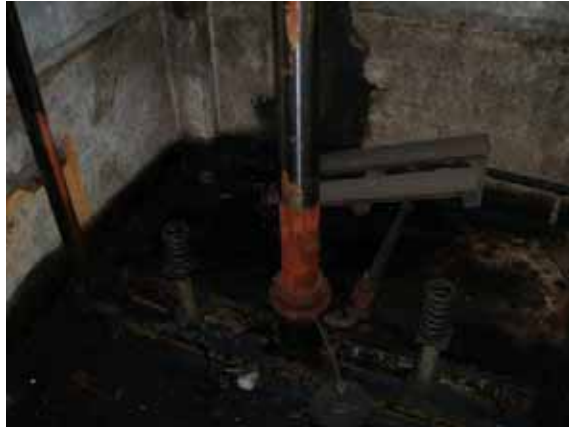
An out of service hydraulic lift elevator is located at the Project. Because the unit was installed prior to 1978 (the USEPA banned the manufacturing of PCB-containing hydraulic fluid in 1976, and the manufacture of PCBs ceased in 1977), EMG is of the opinion that the elevator hydraulic fluid potentially contains PCBs. Visual indication of severe leakage was observed in the elevator pit.

Photo #13:	Severe leakage in hydraulic elevator pit
------------	--

- The hydraulic elevator unit at the Project should be serviced, which could either repair or removal of the equipment. At the time of service, the hydraulic oil should be sampled and analyzed to evaluate for PCB content. If the elevator system is to be removed, sampling and analysis of soil and groundwater should be performed to determine the potential for impact to the Project from this on site source. Based on the results of the sampling event, additional investigation may be necessary.

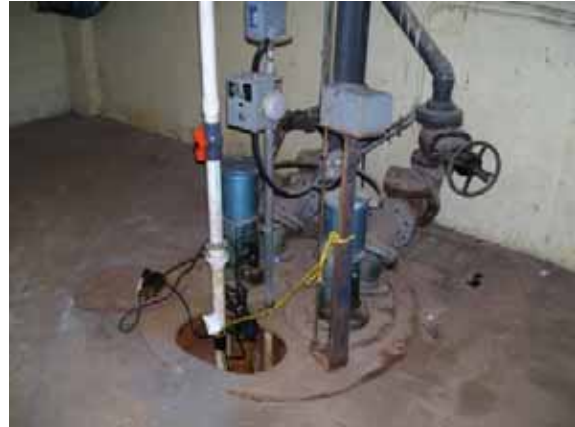
- Trash compactor — The Project operates one out of service hydraulic trash compactor (see Section 6.4 for a further discussion).
- Sump pumps — The Project operates two sump pumps located in the basement of the vacant tenant space. The sump pumps discharge into the sanitary sewer system. No oil sheens or unusual odors were observed in the area of the equipment. The presence of this equipment is not anticipated to have an impact on the Project.

Photo #14:	Sump pump
------------	-----------

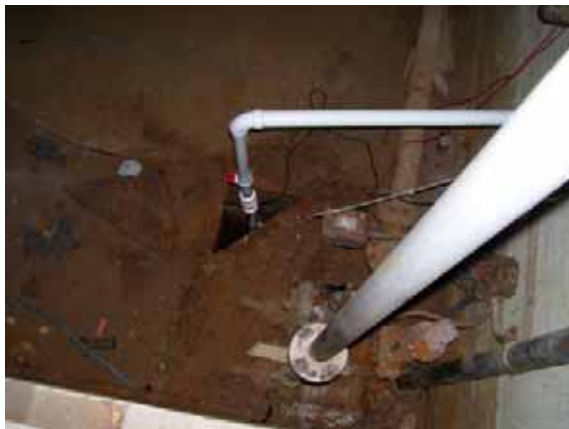
Photo #15:	Sump pump
------------	-----------

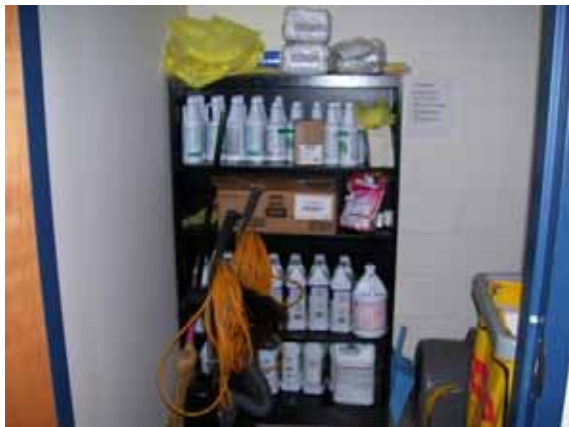
The identified chemicals, materials, and products were observed in their sealed, original containers and in designated storage areas. Materials appeared to be properly stored.

Photo #17:	Routine janitorial and maintenance supplies
------------	---

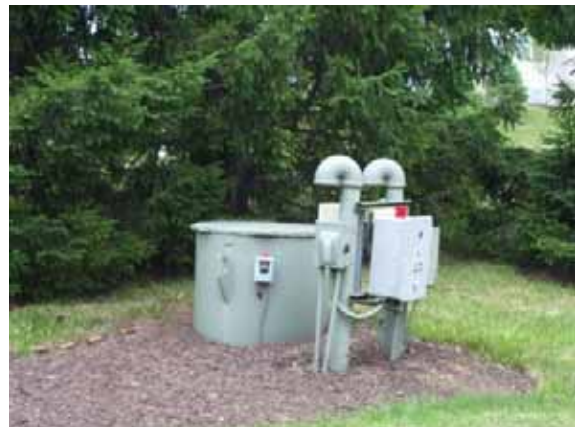
Photo #18:	Sewer ejector pump
------------	--------------------

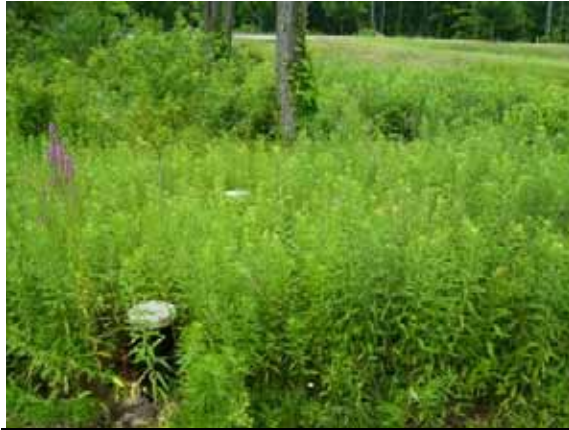
- EMG noted several groundwater monitoring wells at the Project. The monitoring wells were reportedly installed as part of an on-going EPA and PADEP investigation into regional groundwater contamination associated with the nearby North Penn-Area 6 NPL site (see the *Regulatory Review* section below).
- Visual observation of the storm water system did not identify any abnormal accumulation of petroleum run-off or foreign material. No unusual blockages of the storm water control system were observed. No unusual ponding of storm waters was observed. No further action or investigation is recommended regarding storm water systems at the Project.

Photo #19: Monitoring wells

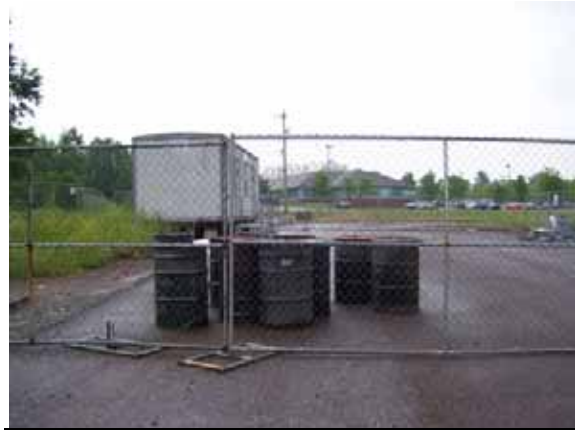
EMG observed several 55-gallon drums in a fenced in area at the Project. The contents of the drums are unknown. Signage on the fencing indicates that the drums are the property of the Environmental Protection Agency (EPA). The POC concurs. There was no information reviewed as a part of this assessment that would indicate what activities would require the EPA's presence at the Project. EMG recommends that any information regarding the drums at the Project and/or any remediation that may be occurring in this area be provided for review. The cost to perform said file review is \$175/hour, with a minimum of 4 hours (\$700) not to exceed 10 hours (\$1,750) without prior Client authorization. Should this information be unavailable or insufficient, additional investigation may be warranted.

Photo #20: EPA owned drums with unknown contents

- EMG recommends that any information regarding the drums at the Project and/or any remediation that may be occurring in this area be provided for review. The cost to perform said file review is \$175/hour, with a minimum of 4 hours (\$700) not to exceed 10 hours (\$1,750) without prior Client authorization. Should this information be unavailable or insufficient, additional investigation may be warranted.

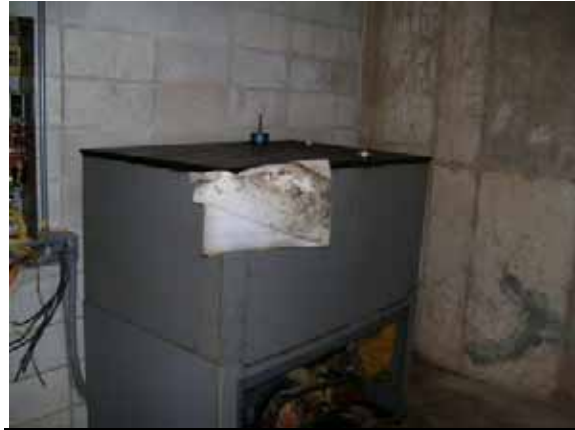
Photo #26:	Elevator equipment room
---------------	-------------------------
