**Re: Nonintrusive Geophysical Subsurface Investigation: UST Search – Former Ennis
Exxon and Fuel Oil Distributor – 106 Baltimore Pike, Glen Mills, PA**

**GEOPHYSICAL INVESTIGATION REPORT
UST SEARCH
FORMER ENNIS EXXON & FUEL OIL DISTRIBUTOR
106 BALTIMORE PIKE
GLEN MILLS, PENNSYLVANIA
5 MARCH 2021**

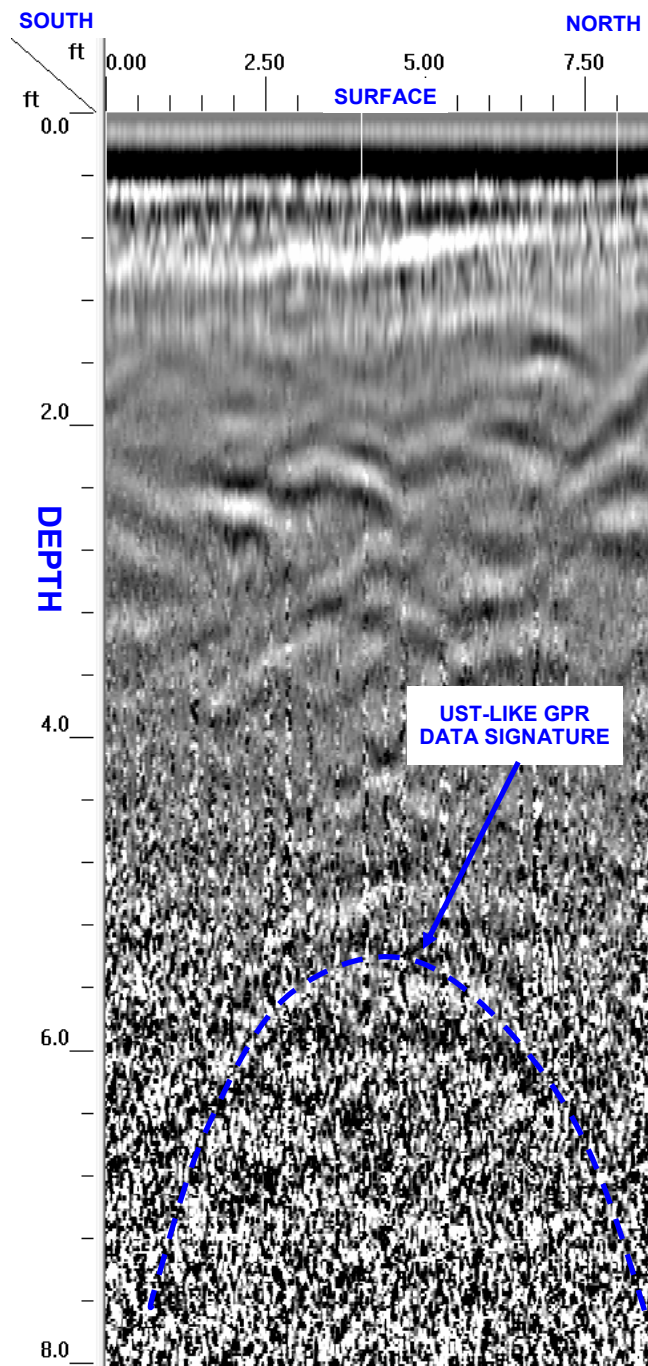
Figure 1-GPR Data Profile

Representative GPR data profile excerpt. The profile extends from south to north over the detected 2,000-gallon tank (refer to the *SAM*). Shown in this profile are the UST-like GPR data signatures indicating the location of a 64"-diameter tank oriented east-west. Depth to the top of the feature based on GPR data approximations is 5' below grade. 400 MHz GPR antenna system, edited from 50 ns.

UST-like GPR data signatures indicative of a 2,000-gallon (64" x 12') tank oriented east-west were delineated near the NE corner of the subject property. In addition, GPR data signatures indicative of two 550-Gallon USTs oriented north-south were also detected located immediately north of the larger tank. The tank locations were field-marked onsite in white paint. Estimated depths to the tops of the tanks based on GPR data approximations is 5' to 6' below grade.

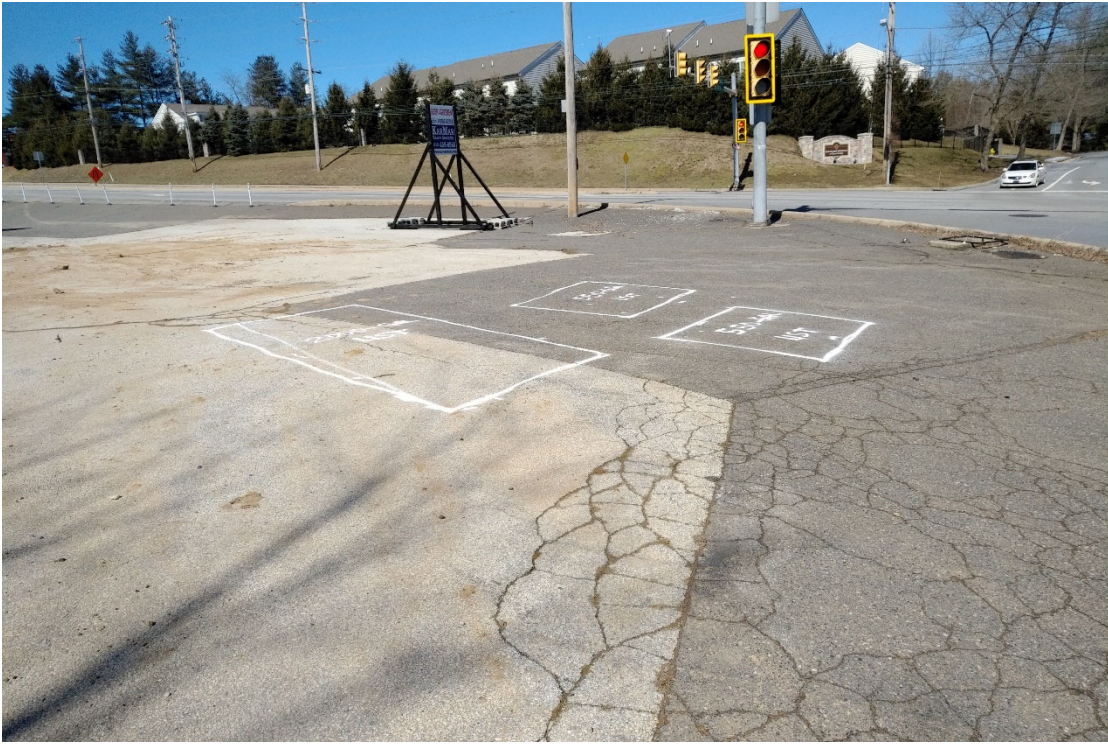
Figure 2 – Site Photograph – Detected and Field-Marked Tank Field at NE Property Corner
